BULETINUL INSTITUTULUI POLITEHNIC DIN IAȘI  
Publicat de  
Universitatea Tehnică „Gheorghe Asachi” din Iași  
Volumul 64 (68), Numărul 2, 2018  
Secția  
HIDROTEHNICĂ

**STUDIES AND RESEARCH OF THE FLOOD EFFECTS OF  
THE JUNE 2016 ON THE RIVER VORONET, ”CÂMP  
CRISTEA” – ”POIANA LUI MACARIE” ZONE**

**MIHAELA AVRAM\*, MIHAIL LUCA and PAUL VIVIAN SION**

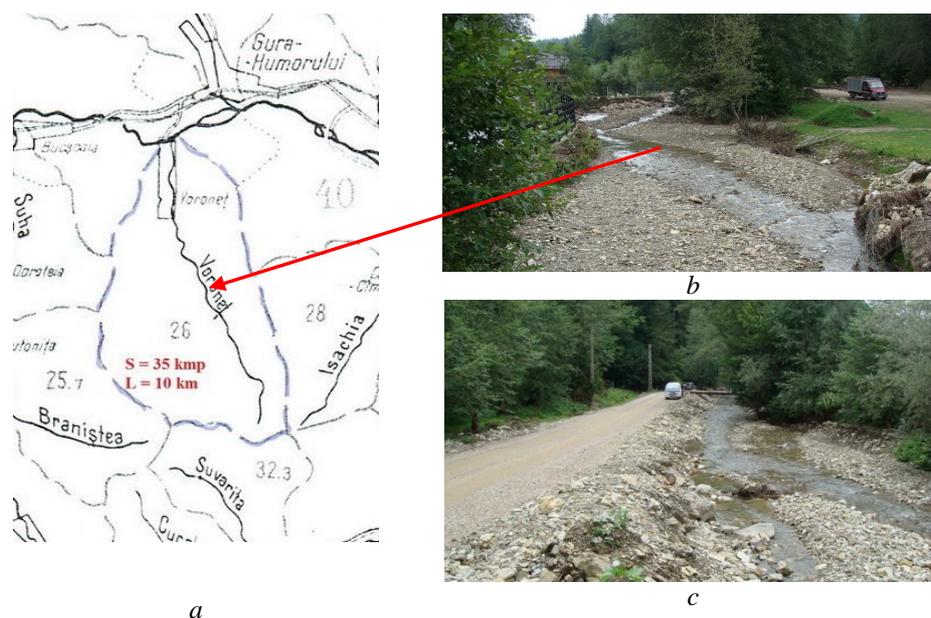
Fig. 3 – Voroneț River hydrographic basin features: *a* – study area; *b*, *c* – detail of Voroneț River in the Camp Cristea area (photo aug. 2016).

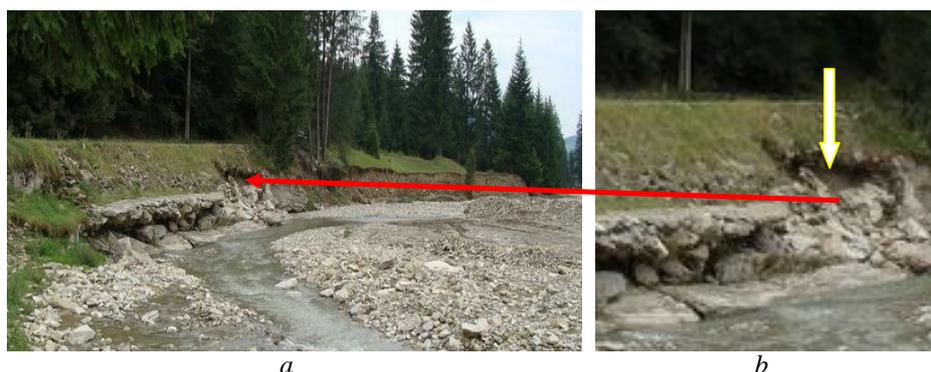
The river banks were eroded (2,600 m of shore) and the riverbed was morphologically transformed (Fig. 4).

Fig. 4 – Erosion forms on the Voroneț River left bank at the DJ 177D road limit „Camp Cristea” downstream area after June 2016 flood: *a* – general view; *b* – detail of the erosion bank (photo aug. 2016).

were degraded and no longer had a functional role in the county road protection (Fig. 4). The hydrodynamic riverbed erosion phenomenon has led to the lowering of shore defence works base elevation. The retaining wall and shore defence concrete slabs were fissured and cracked and later were carried by the water during floods. The lack of rehabilitation works led to a decrease in the shore defence works protective capacity.

DJ 177D county road reconstruction must be correlated with the design and execution of shore defence works on river sectors affected by hydrodynamic erosion. The shore defence works must withstand the water erosive action and also the action of solid flow made of gravel and large stone. Shore defence works must ensure the riverbed banks stability, together with the road shoulder.

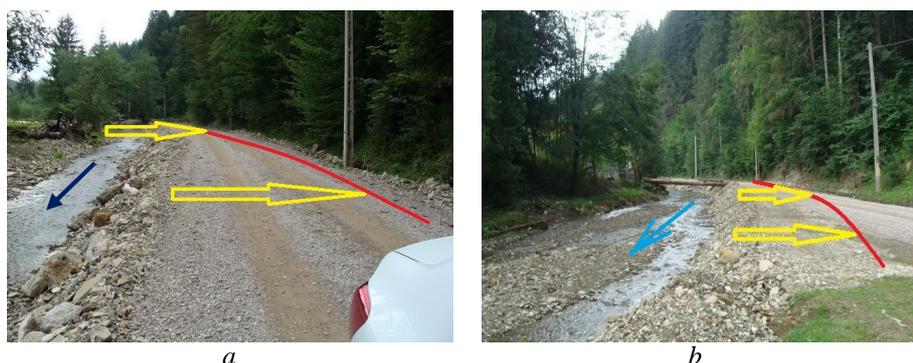
The degradation of the county road resulted over 1500 m in length. The hydrodynamic erosion caused by the flood led to a differentiated degradation of DJ 177D road, up to its total destruction on a length of 400 m (Fig. 5). This situation led to traffic interruption over a period of time.

The road degradation was done through the Voroneț stream advance into the bank (Fig. 5 *a*) and then into the road structure, until the water reached the versant (Fig. 5 *b*). The phenomenon was accelerated by the river’s curvature area lack of shore defence. The geotechnical constitution of the land on which the road is located (ballast and gravel alluvial deposits layers) contributed to the road foundation accelerated erosion.

Fig. 5 – Voroneţ Stream erosive action on the left bank and DJ 177D road: *a* – the starting section of the shore defence and road degradation („Camp Cristea” downstream area); *b* – the ending area of the eroded road section up to the versant (upstream of Brusturos Stream).

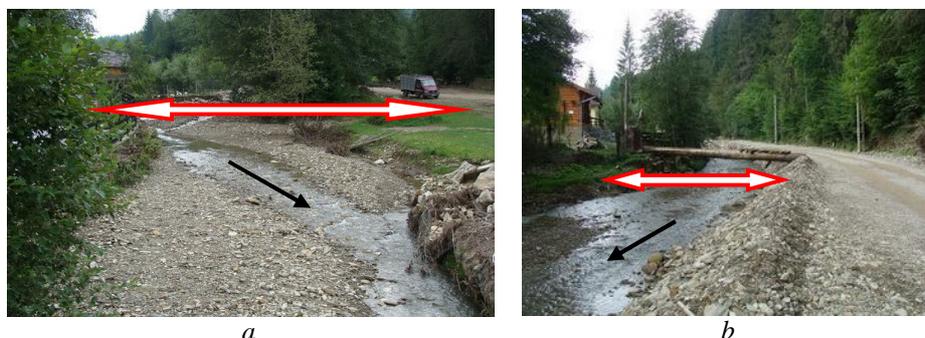
The reduced dimension of the Voroneț River flow section in the degradation area, as well as the lack of shore defence works were the factors which allowed the excessive road erosion (Fig. 6). The old shore defence works

Fig. 6 – Details on the Voroneț Stream riverbed structuring mode at the DJ 177D road limit: a – „Camp Cristea” area; b – „Poiana lui Macarie” upstream area.
