# **BULETINUL INSTITUTULUI POLITEHNIC DIN IA I**

**Tomul LX (LXIV)  
Fasc. 1-2**

**Sec ia  
HIDROTEHNIC**

**2014**

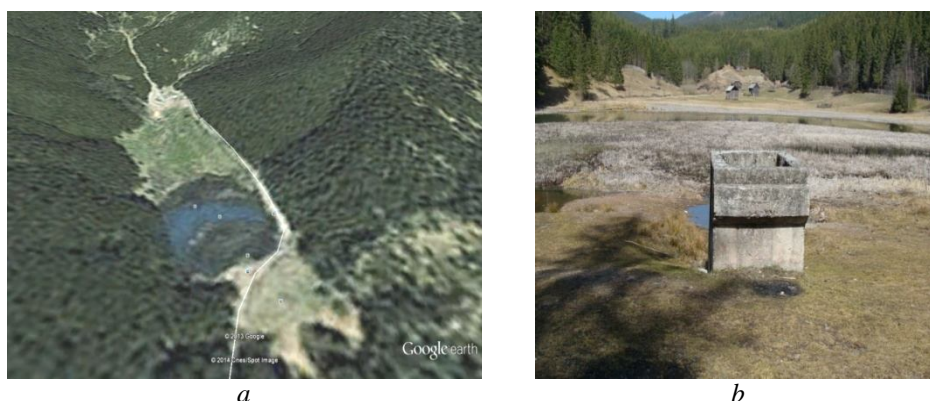
Fig. 1 – Overview of Lake Iezer (year 2014): *a* – Google earth image; *b* – view year 2014.

Riverbed slope limit Iezer is located right in the lake and in the Sulla Mappa of the lake has a depth less developed. Downstream natural threshold which serves as a dam and amended for this purpose be anthropogenic, the bed has a relatively small width but in-depth development of severe burns processes.

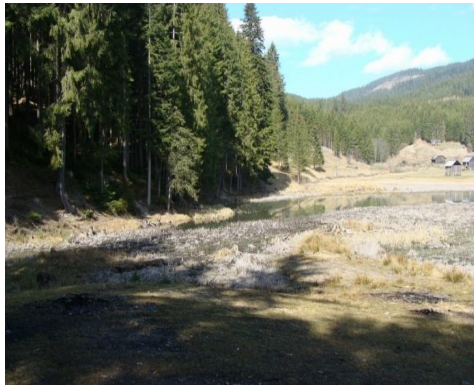
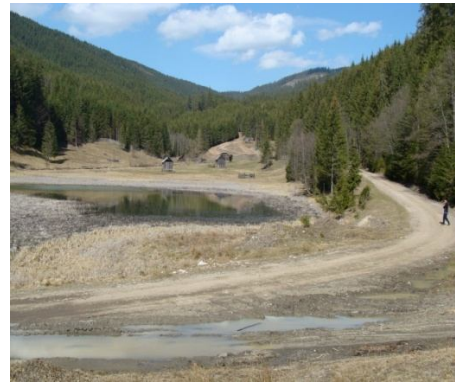
*a* *b*  
Fig. 2 – Overview of Lake Iezer (year 2014): *a* – right; *b* – left.

a) threshold based on the ground with the overflow barrier is broken in a length of 5 ... 10 m; higher volume of the lake was evacuated and Iezer creek flows downstream through the riverbed located next to the right side;

b) a large part of the lake (about 2/3 of the surface) is clogged with silt and wood waste;

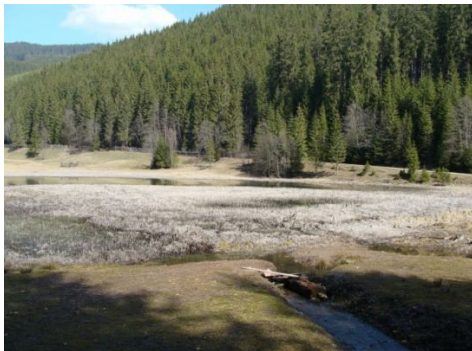
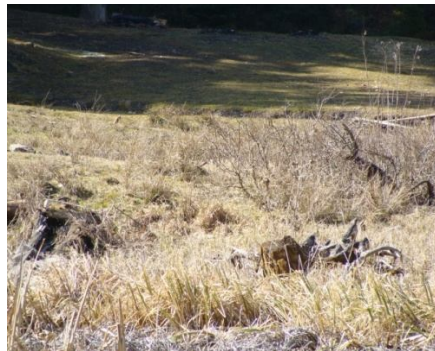
Fig. 4 – Condition silting of the lake: *a* – surface-overview clogged to the dam; *b* – detail on the type of deposit.

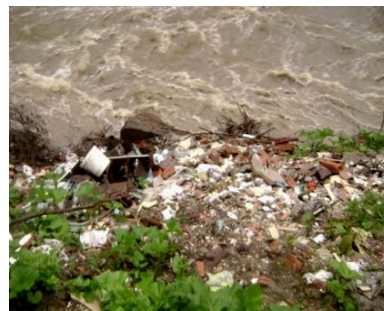
Fig. 3 – Waste dumped in the Tarcău river bed.

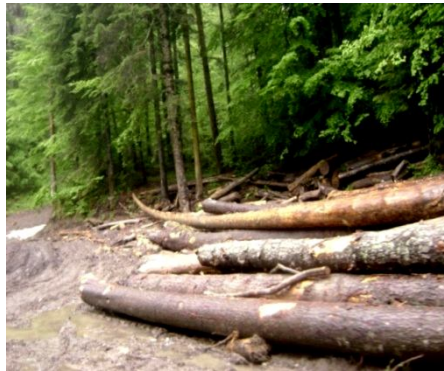
Fig.5 – Logs cut and abandoned in the forests of Tarcău.

In the Tarcău area there is resulting waste from constructions, streets, household and industry (Fig. 5). Industrial waste is the result of the technological process from installations for wood cutting (sawmill). All the debris that is resulting from this activity is not collected and organized properly and transported at the specific places for waste collecting.

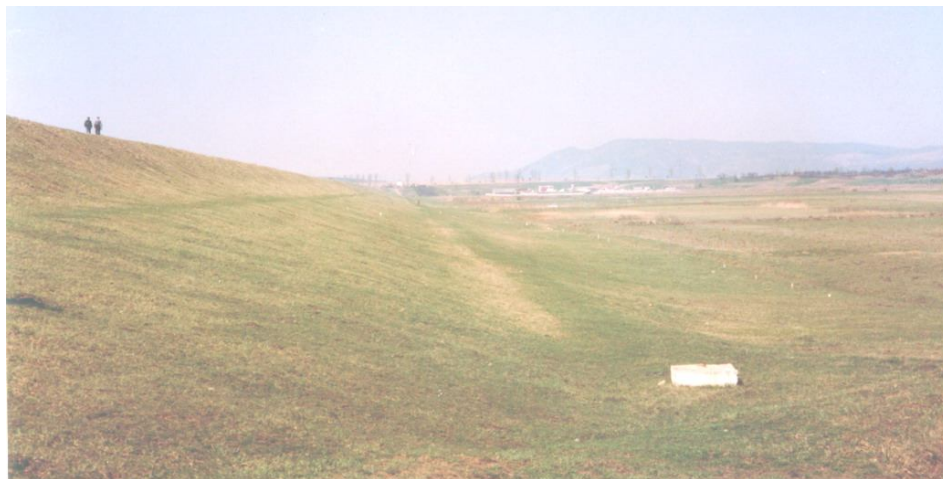
Fig. 2. – The downstream facing of the dam

The analysis shows that the maximum level of infiltration through the dam is traced in calculus section 3 (near the first/initial intake tower, with the parameters of the material:  $k_{med} = 1.16 \text{ cm/s}$ ,  $\rho = 1.915, \dots, 2.031 \text{ kg/m}^3$ ,  $\phi = 8^\circ 15' \dots 15^\circ 35'$ ,  $C_{med} = 0.44 \dots 0.58 \text{ daN/cm}^2$ ). For the storage basin level with the calculus probability 1%, the maximum specific infiltrated flow is  $q_{max} = 15 \times 10^{-8} \text{ m}^3/\text{sm}$ , with the height of trickling downstream face of the dam of  $a_0 = 3.82 \text{ m}$  (Fig. 2).

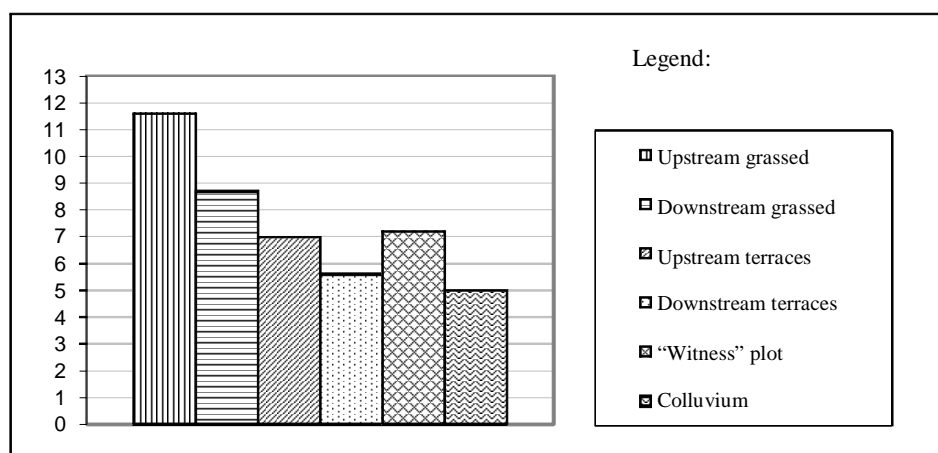
Fig. 1 – Charts representing the residues content in the soil.
