BULETINUL INSTITUTULUI POLITEHNIC DIN IAȘI
Publicat de
Universitatea Tehnică „Gheorghe Asachi” din Iași
Volumul 64 (68), Numărul 2, 2018
Secția
HIDROTEHNICĂ

UPDATING THE PIPE NETWORKS LAYOUT PLAN USING MODERN DETECTION EQUIPMENT

ȘTEFANIA CHIRICA*, MIHAIL LUCA and IUSTINA LATEȘ

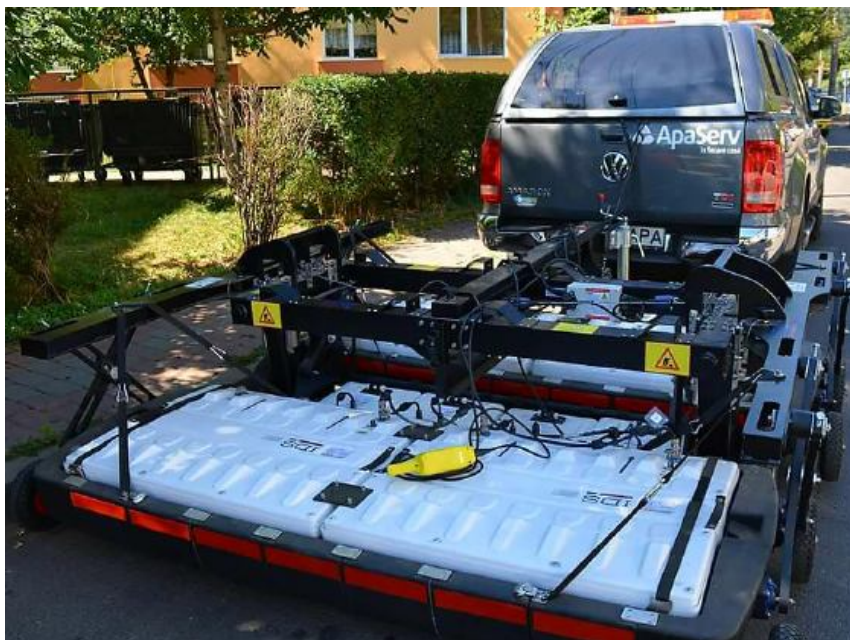
Fig. 1 – The equipment uses electromagnetic radio waves to investigate.

The ground penetrating radar has been used lately due to its immediate and high quality results. The georadar is a modern detection equipment used to investigate buried pipe networks from above the ground (Chirica, 2017). The data obtained from the field surface scan is processed with the help of special software and the results are analysed by experienced operators. The equipment (Fig. 1) uses electromagnetic radio waves to investigate underground elements. The technology has been adapted to locate water losses in buried pipes and investigate the condition of underground networks. Leaks are identified due to the differences in the density of the land in which the pipelines are incorporated and its water content (Themistocleous *et al.*, 2013).

The penetration power of the system depends on the length of the radiation wave and the electrical permittiveness of the terrain. The use of this technology requires knowledge of the properties of the field to be investigated, especially its conductivity. Terrains characterised by high conductivity, such as those composed of very fine particles or with high water content (Fig. 2), can provide misleading results (Postăvaru, 2015). Georadar acquired field data is entered in the pipeline network map as well as in the GIS monitoring system.

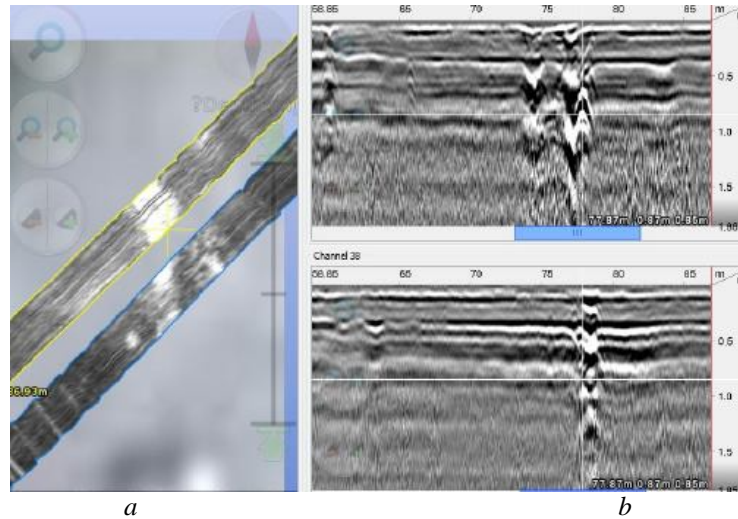
Fig. 2 – Water loss detection using the ground penetrating radar:
a – detection equipment; *b* – charts with the results of field investigations
 (Postăvaru, 2016).

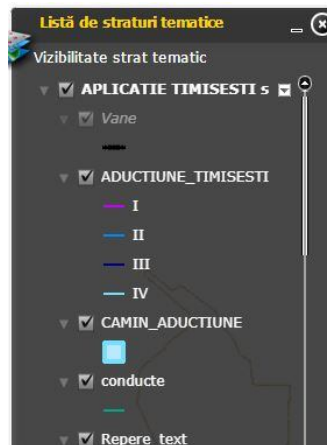
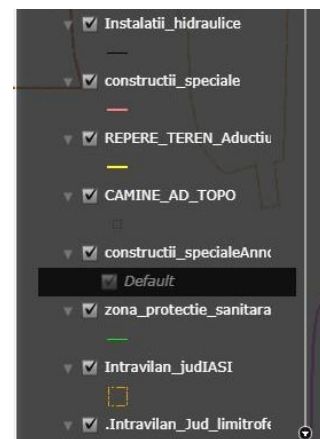
Fig. 4 – Timișești – Iași supply pipe I characteristic layers defined in ArcGIS model.

Currently, the Timișești – Iași supply pipe I model contains an array of potable water supply pipes characteristics, such as (Figs. 4 and 5.): valve homes, hydraulic features, special structures, sanitary protection area, etc. The
