BULETINUL INSTITUTULUI POLITEHNIC DIN IAȘI
Publicat de
Universitatea Tehnică „Gheorghe Asachi” din Iași
Volumul 63 (67), Numărul 1-2, 2017
Secția
HIDROTEHNICĂ

ANALYSIS OF HYDROLOGICAL RISK PARAMETERS IN TROTUȘ RIVER BASIN

AVRAM MIHAELA and LUCA MIHAIL*

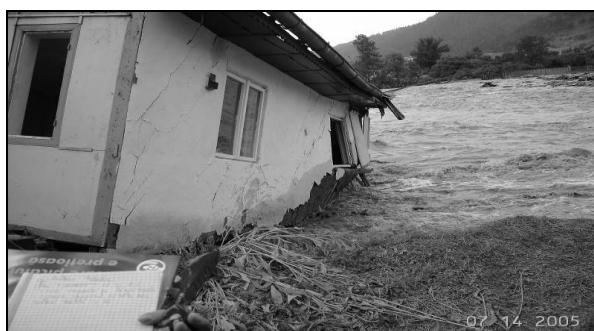
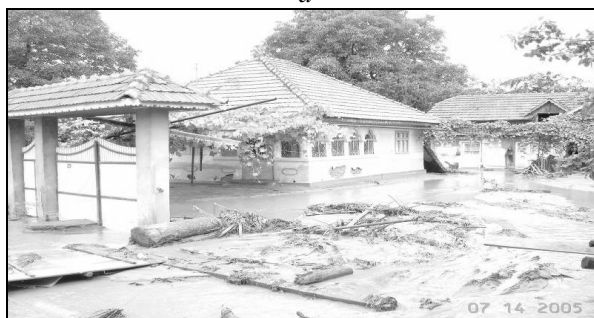
Fig. 6 – Photo surveys regarding Comănești Town from Trotuș River basin in 2005: *a* – coastal area; *b* – town area (A.B.A. Siret, 2005).

The Trotuș River flash floods from July has partially and totally degraded housing, household annexes, social and economic constructions, crops, forest lands (Fig. 6). The flood caused extended damages to road infrastructure (national and local roads), railroads, bridges, public interest area access roads etc.

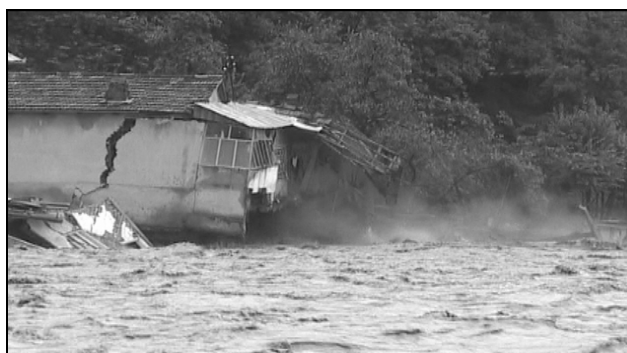
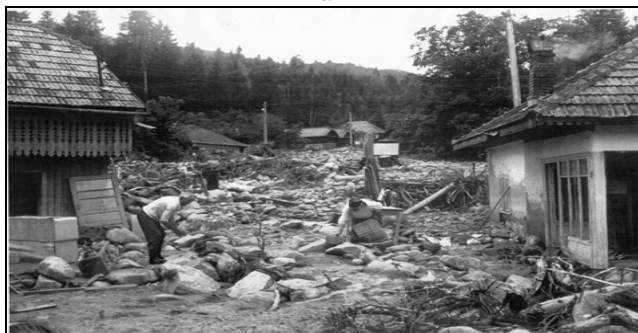
Fig. 7 – Photo surveys regarding Asău Town from Trotuș River basin in 2005:
a – coastal area; *b* – town area (A.B.A. Siret, 2005).

- g) increased rainfall – water drainage on slopes and river concentration due to the unsupervised deforestation;
- h) continuous degradation of the basin regulation works of the non-permanent riverbeds (torrential) flow, a situation which reduces the flow time and increases tributary flow in the main riverbed (Fig.7);
