BULETINUL INSTITUTULUI POLITEHNIC DIN IAȘI
Publicat de
Universitatea Tehnică „Gheorghe Asachi” din Iași
Volumul 63 (67), Numărul 3-4, 2017
Secția
HIDROTEHNICĂ

THE ANALYSIS OF “WATER LOSS” PHENOMENON FROM PIPE NETWORKS

ȘTEFANIA CHIRICA *

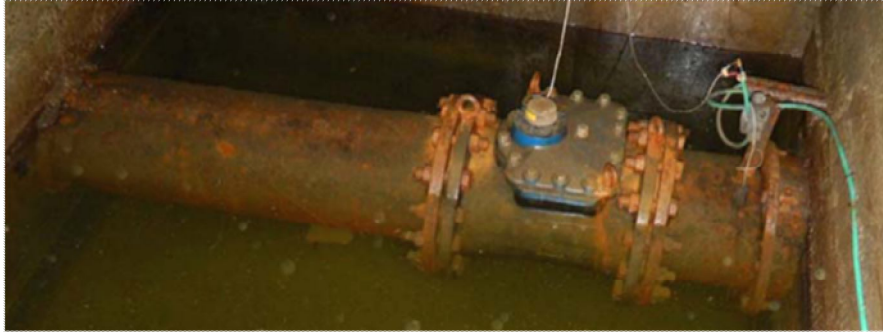
Fig. 3 – Electromagnetic flowmeter fitted to a 400 mm diameter steel pipe inside Cerna pumping station, Iași.

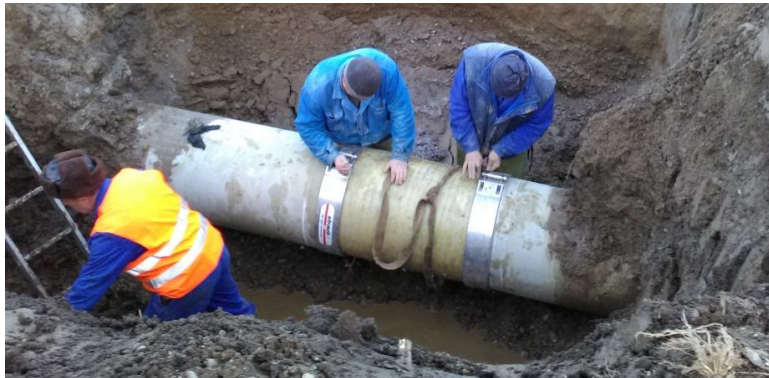
Fig. 4 – The replacement of a 600 mm diameter GRP (PAFSIN) pipe section in Miroslovești locality, Iași county.
