BULETINUL INSTITUTULUI POLITEHNIC DIN IAȘI

**Secția
HIDROTEHNICĂ**

2019

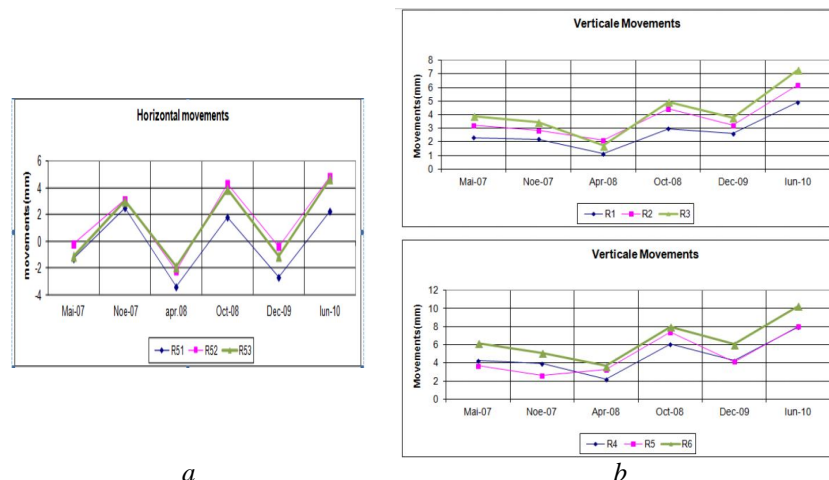
Fig. 1 – Charts of the displacement of the landmarks fixed on the Cerna dam:
a – horizontal movements; *b* – verticale movements (Bălă, 2014).

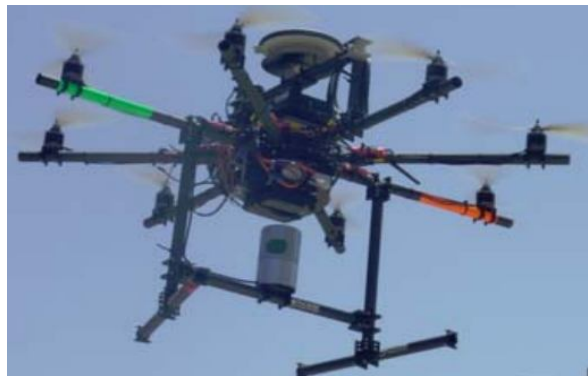
Fig. 3 – Phoenix AL-2 device (Pîrvulețu, 2016).

There are many modern equipment based on LIDAR technology, which can be install on various road, rail, naval and air vehicles. Using drones is the most preferred option at this moment. An example of drones equipped with LIDAR devices are those in the PHOENIX AERIAL SYSTEMS range (Fig. 3).

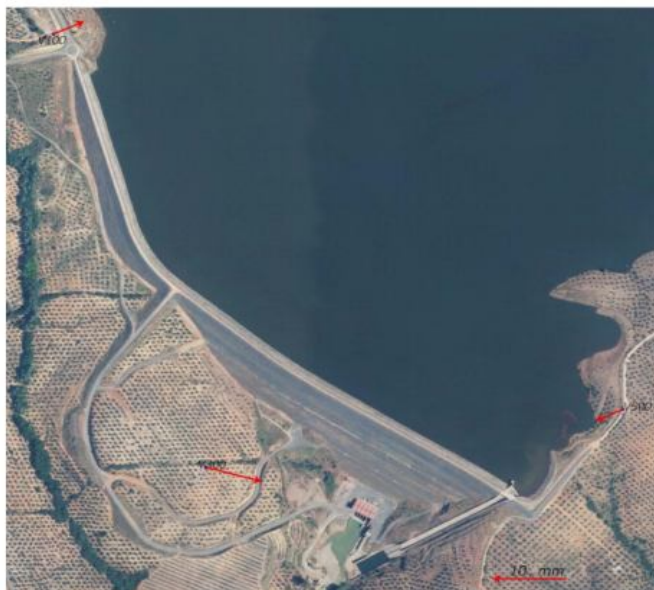
Fig. 6 – The horizontal displacements estimated for V100, V300, V500 Pillars as part of the monitoring of Arenoso dam (Acosta, 2018).

Station	Horizontal Displacement (mm)	Geodetic Azimuth of the Displacement Vector
V100	4.5	65°53'31.8"
V300	10.3	104°33'34.9"
V500	3.9	244°10'43.9"

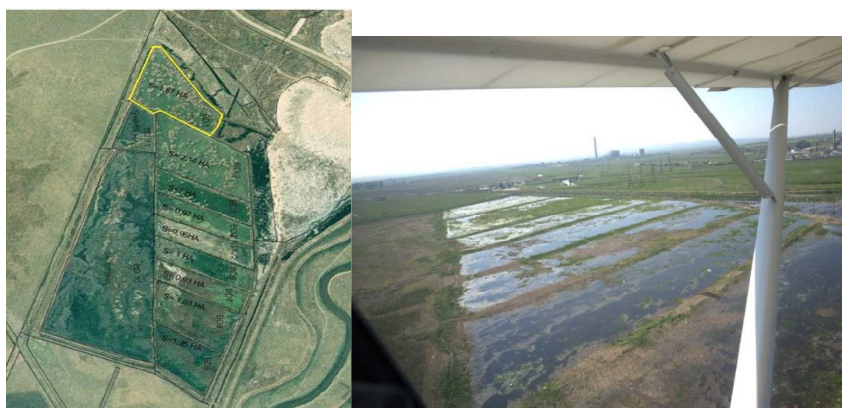
Fig. 1 – Sludge storage in Tomești.

The warehouse was divided into 11 compartments (Fig. 1) of different surfaces. Between the compartments there are breaches of water and sludge circulation. The total volume of the deposit is 225,000 m³.

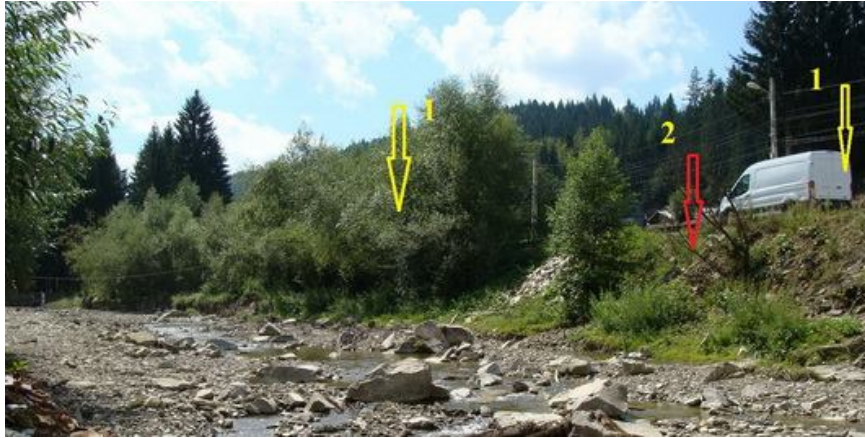
Fig. 3 – General view of the DJ 177D location at the border of Voroneț River bed:
1 –Voroneț District road route and near „Voroneț Monastery”;
2 – the state of the shore protection (Photo Luca, 2016).

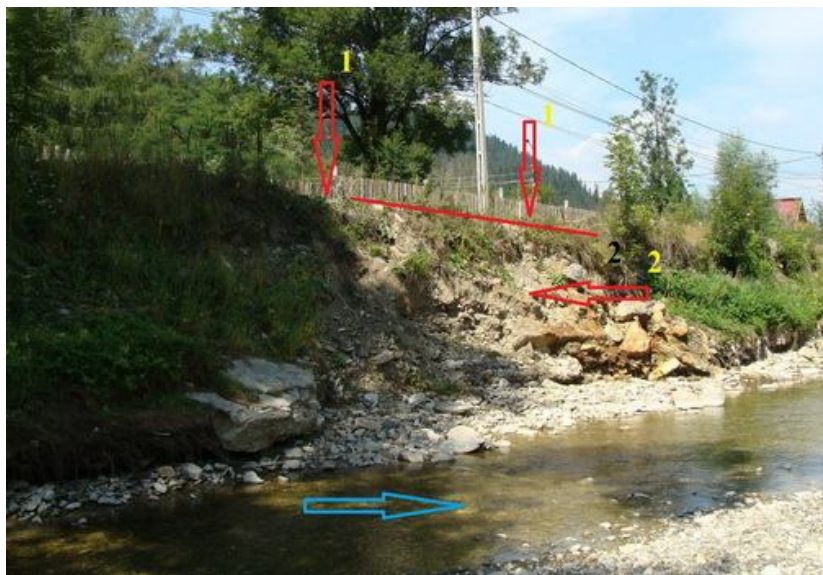
Fig. 5 – General view of the DJ 177D degradation located in Voroneț District due to the erosive action of the water during floods: 1 – the erosion of the road shoulder with ingress in the road; 2 – the shore protection fully degraded and shore erosion (Photo Luca, 2016).

The result of the combined action over time of the two factors resulted in the following degradation phenomena to the county road: erosion of the road shoulder, washing of the road supporting layer, degradation of the resistance structure, displacement of road sections. This phenomenon is present on the road section located near the monastery (Fig. 5).

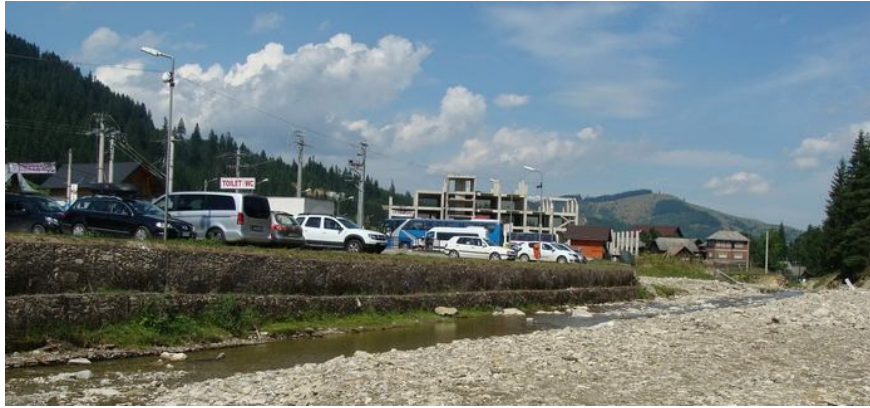
Fig. 6 – General view of the structural state of the shore protection on Voroneț River in Voroneț District – the monastery parking area (Photo Luca, 2016).

The analysis conducted in the field, in the area of Voroneț Monastery, highlighted the state of degradation of the former shore protection, but also the state of the one that replaced it (Fig. 6). In this context, the water flow and alluvial material intensifies the degradation state of the road and riparian constructions. The riverbed carries during floods an alluvial material in which gravel and stone of different sizes, including boulders, prevails. The alluvial material acts on the bank made of a layer of poorly cohesive rocks, but with intercalations of hard rocks, causing a strong erosion phenomenon. In this context, the selection of shore protection solutions should take into account the extremely strong and diversified hydro-transport phenomenon.

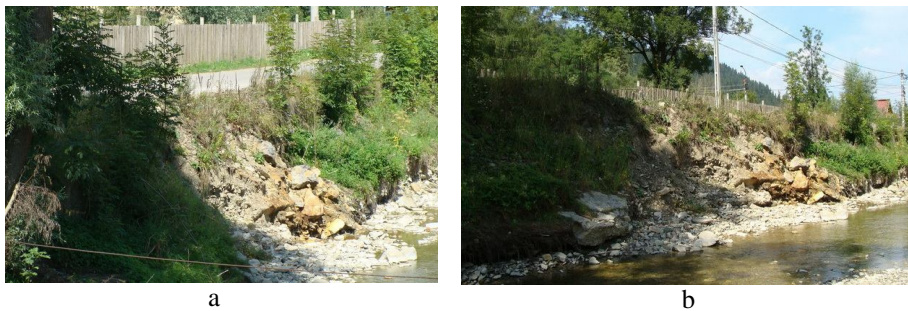
Fig. 7 – Details on the erosion phenomenon of Voroneț River bank and the degradation of DJ 177D in Voroneț District; a – blocking of the shore erosion with large stones; b – highlight of the erosion area on the shore protection line (Luca, 2016).

The interventions on the current shore protection rehabilitation on the Voroneț River within the locality are missing, or the ones made have not resisted over time to the erosive water action. Local interventions to limit the degradation of the Voroneț River left bank are not effective. The rock deposits strength is limited to high transport speeds generated by floods with 1% probability calculations as the one from 2016 (Fig. 7).

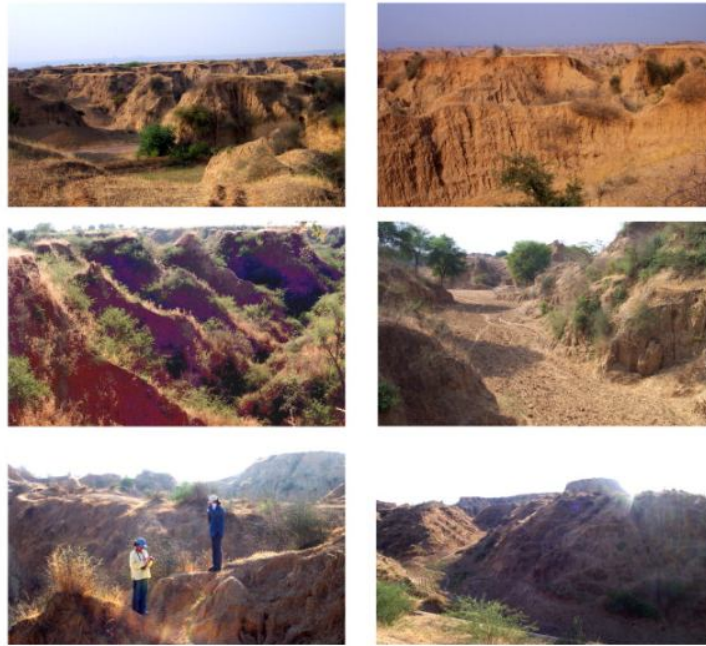
Fig. 7 – Types of ravines located in Madhya Pradesh, India.

The ravines in this area are very intense, with a depth of 60,...,80 m and are spreading a lot in the region and therefore have serious problems in land use planning and cause a huge loss in agricultural production.

The authors of the article "Interferometric SAR for the characterization of ravines as a function of their density, depth and surface cover" highlight the fact that the formation of ravines is also due to anthropogenic factor such as: poor agricultural practices, mining and deforestation. Author's research on India's ravages reveals that they occupy 0.5 million ha at the expense of fertile farmland (Fig. 7).

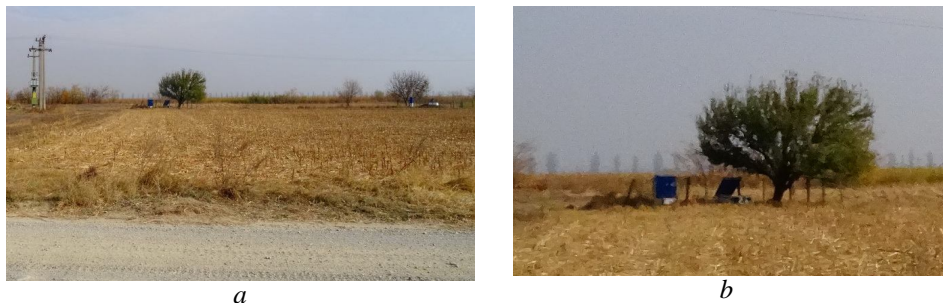
Fig. 4 – The placement of the catchment wells: *a* – general view of the site; *b* – detail on the well structure, year 2015 (Photo Luca, 2015).

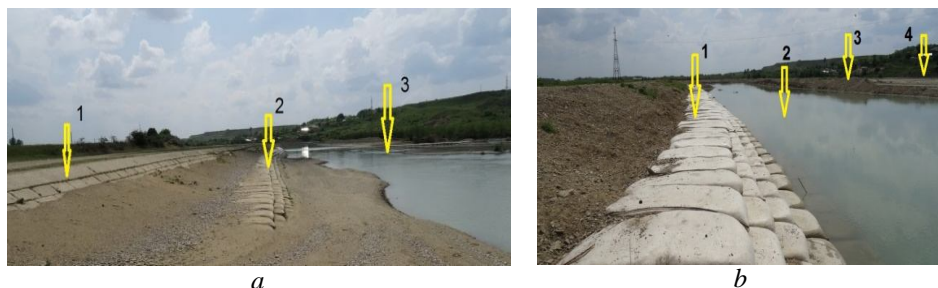
Fig. 5 – General view left bank shore protection downstream of deviation area: *a* – left bank with the old and new left bank shore, 1 – concrete slabs, 2 – geocontainers, 3 – deviated riverbed; *b* – geocontainers shore protection, year 2015 (Photo Luca, 2015).

d. The left shore protection work is made of the old structures (concrete slabs) and the new type of shore protection made of geocontainers (Fig. 5). The concrete slabs shore protection is discontinuous in length, being degraded in proportion of 35,...,80%. On some sectors it is completely degraded.

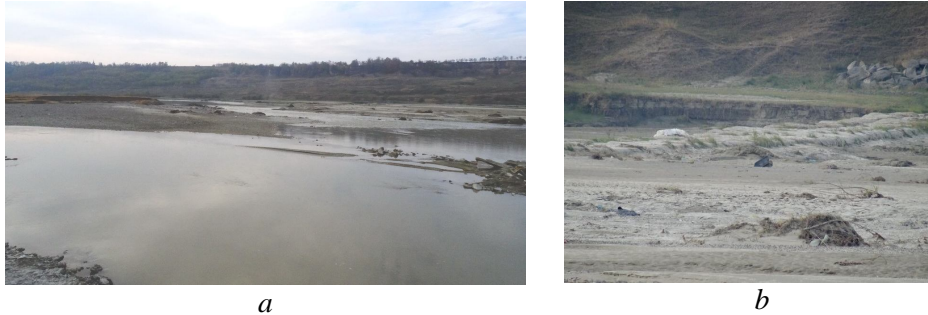
Fig. 7 – The state of the riverbeds separation area around the catchment: *a* – general view of the separation area with closing dyke; *b* – detail on the dyke degradation, year 2018 (Photo author).

f. The 2016 flood caused significant degradations in the structure of regulation and shore protection works. The closure dyke of the old riverbed was broken, which affected the catchment flow rate of the wells (Fig. 7). This situation forced the urgent restoration of the dike.

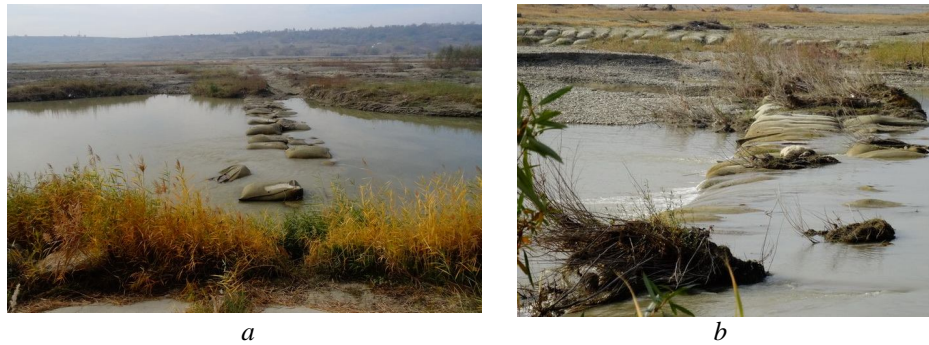
Fig. 8 – Aspects regarding the degradation of bottom sills on the deviated minor riverbed, year 2018; *a* – general view; *b* – detail on the bottom sill state (Photo Luca, 2018).

g. The flood of 2016 caused significant degradation to the constructive structure of the bottom sills by displacing the geocontainers, breaking them, emptying the material etc. The rehabilitation works applied in 2017 helped to restore the operating parameters of the bottom sills (Fig. 8).

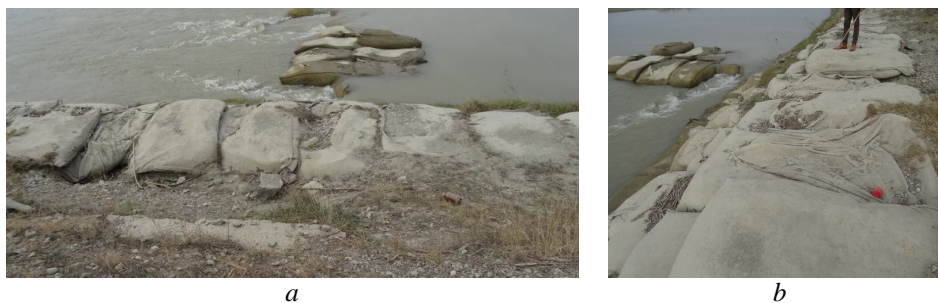
Fig. 9 – Degradation of shore protection made of geocontainers on the deviated minor riverbed, year 2018; *a* – elements degraded by floaters in water; *b* –geocontainers degradation on the superior side of the shore protection (Photo Luca, 2018).

h. The 2016 flood caused significant degradations to the shore protection structure made of geocontainers by breaking the geotextile and partially emptying the material. Rehabilitation works applied in 2017 contributed to the restoration of the bottom sills' operational parameters (Fig. 9).
